Aberdulais Aqueduct

Structural Inspection Report

Waterways Recovery Group

Project Number: 10925

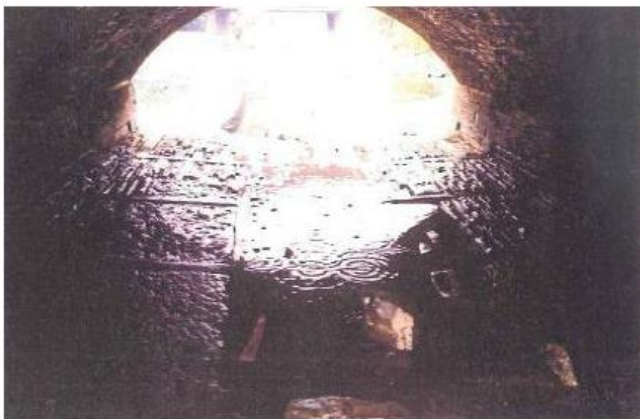
Arch 1 stone/timber bed protection

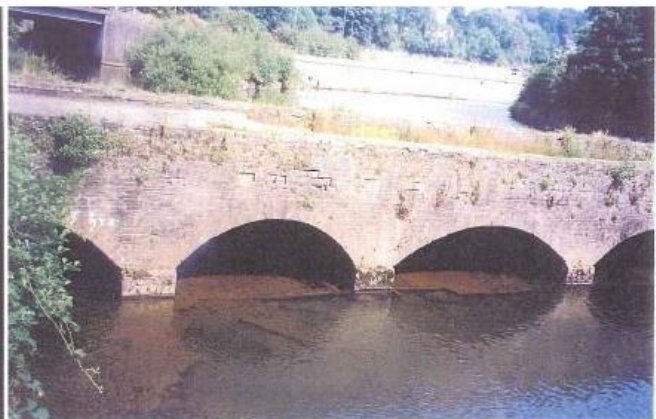
Arches 1-3, deteriorated bed protection

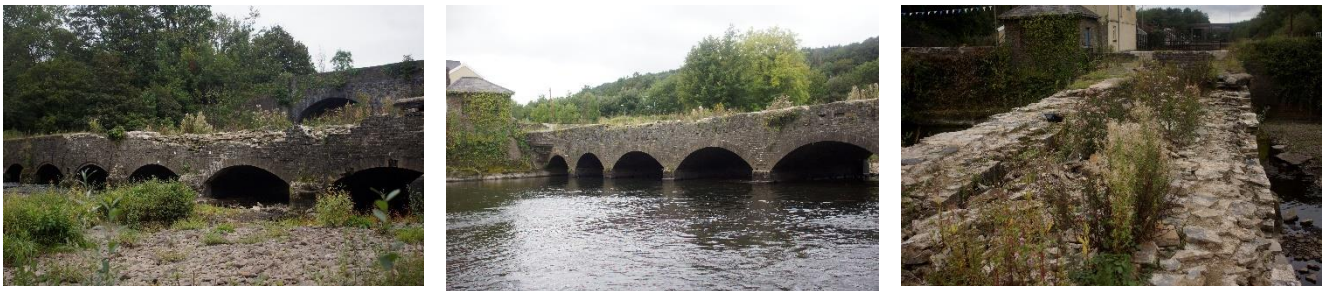
- 5.3.2.1 The most visually significant defect affecting the aqueduct is the section of broken down masonry over arches 3, 4 and 5. Over this length the upstream and downstream channel walls have lost a proportion of their masonry and the canal channel is full of masonry debris.

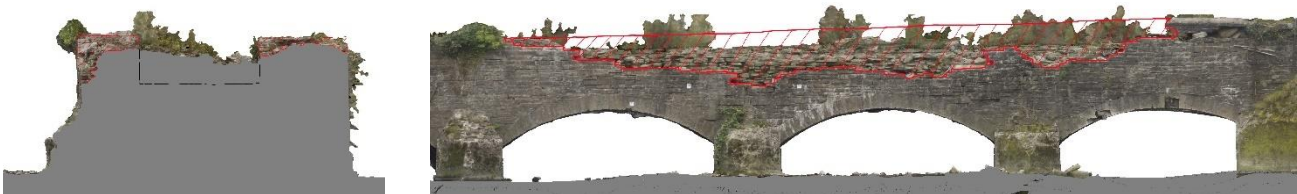
- 5.3.2.2 The upstream channel wall (C) has lost 0.5m height over its full width and 1.25m height of the upstream facing (C1). The downstream channel wall (D) has lost 0.25m height over its full width and 0.5m height of the downstream facing. Both walls (C & D) are affected over a length of 16m with the damage reducing towards both ends and worst at the centre.

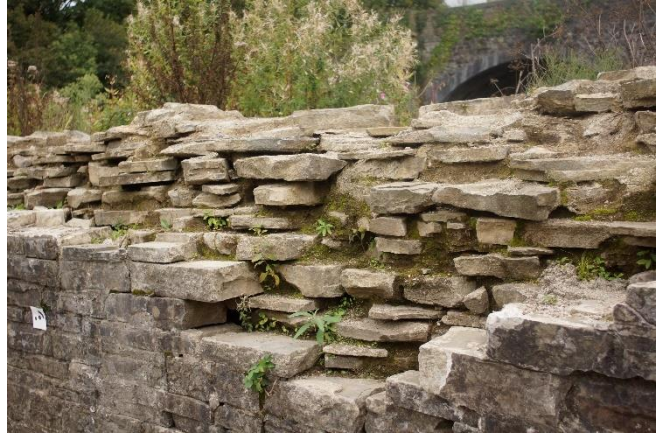
5.3.2.4 The upstream face of the upstream channel wall (C1) is broken down to a lower level than the core work behind and there is a void between the remaining facing stone and core work. This in conjunction with the distortion discussed in section 5.4.5 suggests the facing stone (C1) is not well bonded to the core material and has moved away from it.

5.3.2.5 Although this is a significant defect in the masonry it is not progressive and is unlikely to propagate further deterioration without outside influence.

5.3.2.6 The exposed core work and void behind the facing stone both increase the likelihood and consequence of vegetation growth. The uneven surface and void are likely to collect soil and seeds encouraging plant propagation. The voids and more uneven stonework will allow roots into the masonry and are less robust against the forces generated by this. Combined with vegetation growth the void behind the facing has the potential to cause a larger collapse of the facing masonry.

5.3.2.7 Likewise, the exposed core and void behind the facing increase the vulnerability of this area to hydraulic damage during flood events. The reduced crest height will increase the frequency this area is overtopped and increase the water velocity in this location. In addition, the exposed core work and voided facing stone are less robust against these hydraulic forces.

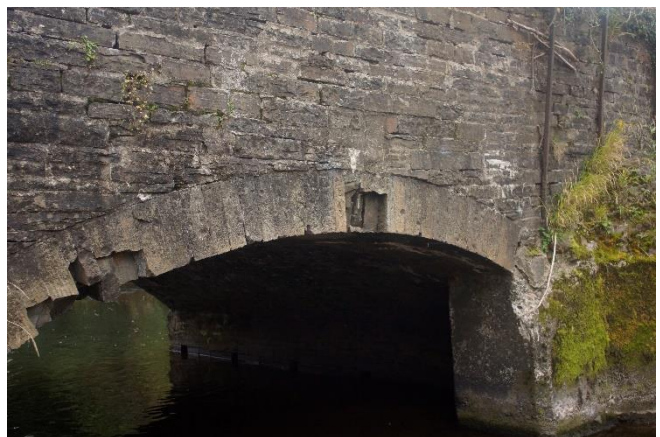
5.3.3.1 On the upstream face of arch 3 (B), 7 of the facing arch (B4) voussoirs are damaged. Each have lost around half of their face.

5.3.3.2 This defect does not pose a significant immediate risk to the monument but is a general deterioration of the masonry robustness.

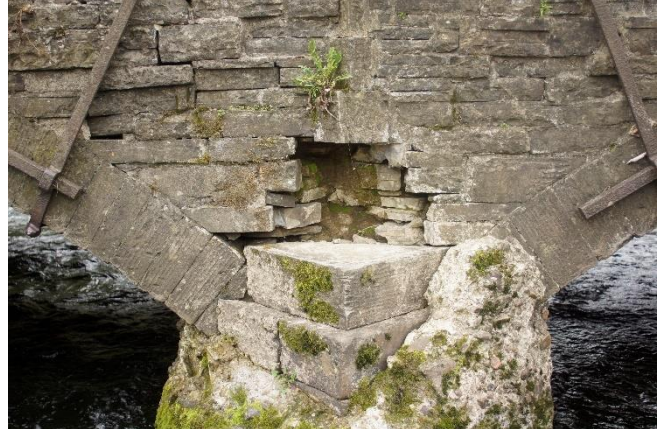
5.3.4.1 Between arches (B) 6 and 7 the stone breakwater (B7) on the upstream edge is exposed and has lost 2 No stones exposing the core material behind. The stone is exposed due to degradation of the concrete breakwater (B6) as described in section 5.4.4. The top two stones forming the breakwater are still in place but look vulnerable.

5.3.4.2 This defect reduces the robustness of the adjacent facing masonry making it vulnerable to hydraulic action or impact. It poses a risk to the monument of further loss of stonework and potentially a more significant local collapse.

- 8.5.3 **Missing Area of Stone Breakwater** – The exposed core material should be cleaned of any soil or other deleterious materials. The missing areas of facing and stone breakwater should be replaced with new stonework in lime mortar. New stone and mortar should be of similar type, colour and finish to the existing and the size should be to match all available evidence for the original stone breakwaters. Stainless steel pins should be included to strengthen the bond between the breakwater stones and the between he breakwater and facing.

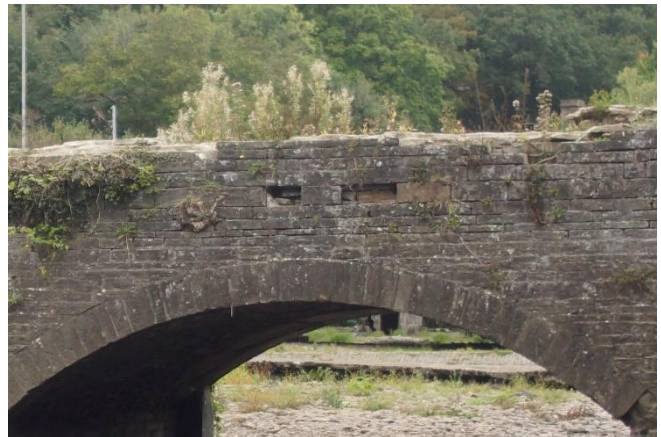
5.3.5.1 Above arch (B) 5 on the downstream face of the downstream channel wall (D) 2 No facing stones are missing exposing the core behind.

5.3.5.2 This defect reduces the robustness of the adjacent facing masonry making it vulnerable to hydraulic action or impact. It poses a risk to the monument of further loss of stonework and potentially a more significant local collapse.

- 8.6.3 **2 No Missing Facing Stones** – The two number missing stones to the downstream face above arch 5 should be replaced with new stones in lime mortar.
- 8.6.4 **Damaged Arch Voussoirs** – We recommend the damaged arch voussoirs to arch 3 are repaired by carefully removing and replacing the affected stones in lime mortar. New stone and mortar should be of similar type, colour and finish to the existing and the size should be to fit the gap with minimal joints either side.

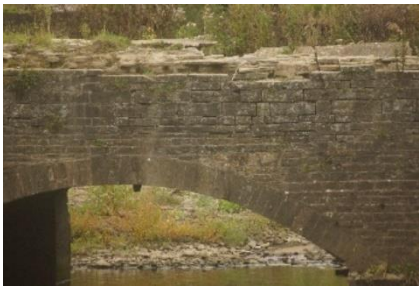
Area of general pointing loss

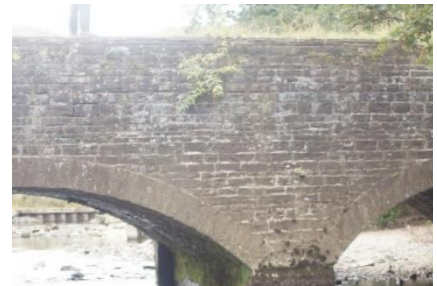
Area of generally reasonable pointing

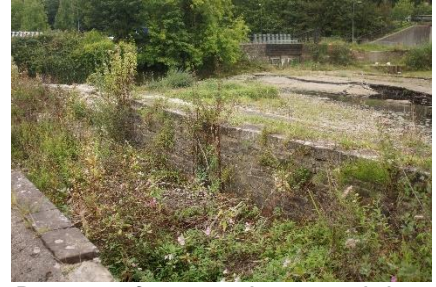
Dense soft vegetation growth in canal channel (E) and moderate growth on inside face of upstream channel wall (C).

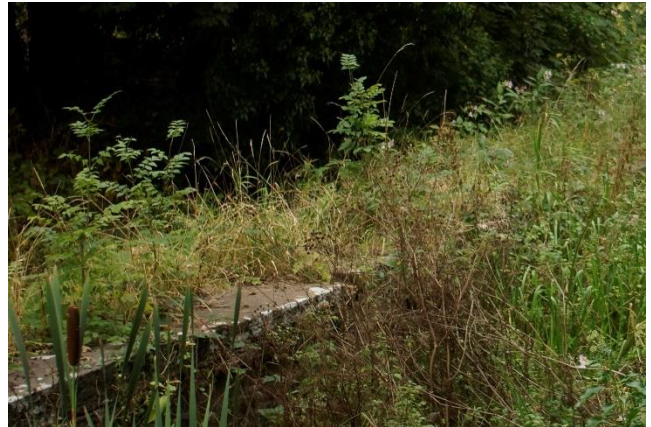
5.4.3.4 Amongst the soft vegetation growth there are some saplings taking root in the channel wall heads (G and H) and channel base (I) of the retained canal section. Most of these are small plants approx.. 600mm high but there was at least one over a metre high.

5.4.3.5 The risks posed to the monument is an ongoing process of root growth opening joints in the masonry, allowing further vegetation growth and displacing and damaging the stonework.

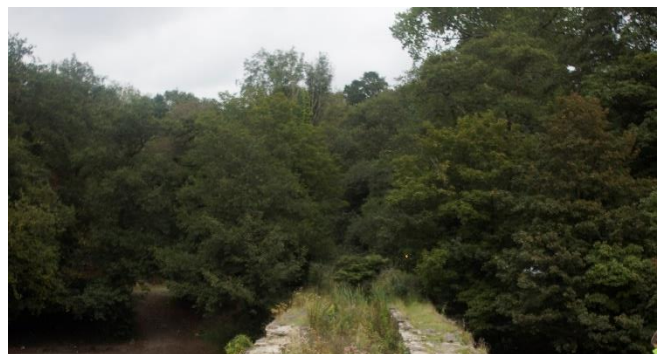
5.4.3.6 Both sides of the retained canal section are mature woodland. There are large trees and shrubs growing close to the monument with branches overhanging it.

5.4.3.7 There are three separate risks posed to the monument by the proximity of the trees. The root zone of the trees almost certainly extends below the monument and may cause swelling or shrinkage of the ground as the trees grow and die. The overhanging branches of the trees will increase the likelihood of woody vegetation growth taking root on the structure. Finally, if any trees fall, they could cause damage to the structure by impact or by disturbing the ground below the monument.

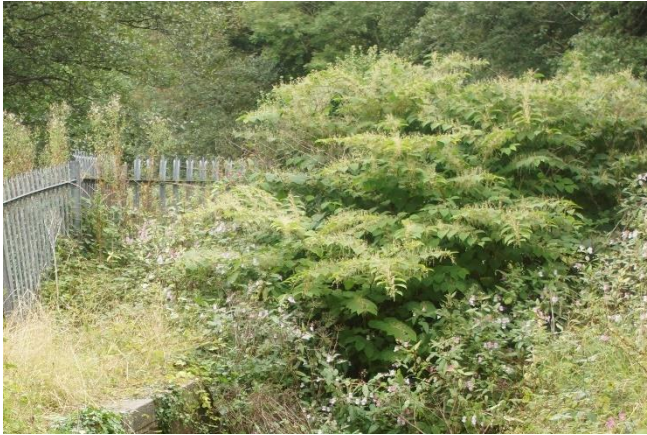
5.4.3.8 On and around the retained canal section there are Himalayan Balsam and Japanese Knotweed plants, this is particularly the east end of the canal channel (I) and the downstream channel wall (H). Both plants are listed on schedule 9 of The Wildlife and Countryside Act (WCA) 1981 making it an offence to plant or allow it to grow in the wild. As such landowners have a duty of care to prevent its spread from their property. Himalayan Balsam propagates via seeds which can travel great distances by water so its presence near watercourses is undesirable.

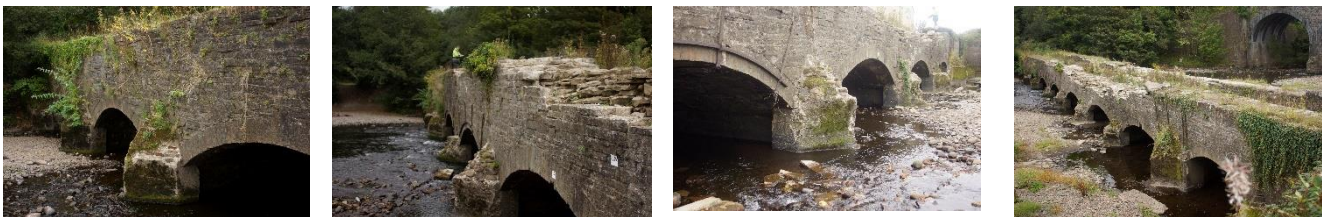
5.4.4.1 All the concrete breakwaters (B6) to the upstream face have mechanical damage particularly to the corners. The degree of degradation increases for the breakwaters closer to the channel centre. The extent of degradation is significant for 5 of the 11 breakwaters and of these 5 one is almost completely compromised as described in section 5.3.4.

5.4.4.2 This degradation is likely the result of abrasion and collision from debris in flood flows including stones and boulders in the base of the river channel. It is likely the concrete was added to the breakwaters because the stone breakwaters were not performing although we have not seen any evidence of this.

5.4.4.3 The risks posed to the monument is an ongoing deterioration and erosion of the breakwaters until the stone breakwaters underneath are exposed to the same impact and abrasive forces.

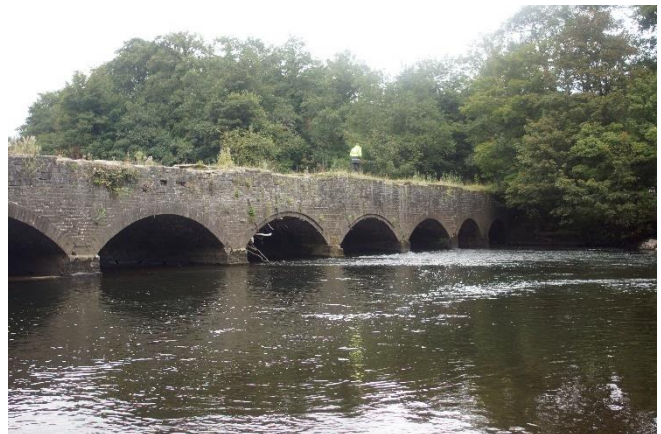
5.4.6.3 On the downstream face the bed level is reduced and there is a large deep pool downstream of the aqueduct. This prevented access to the downstream face making it difficult to assess the risk of undermining.
