Horncastle and Tattershall/ Coningsby Canal Heritage (H.A.T.C.H)

Horncastle & Tattershall Canal

Feasibility Study

April 2005

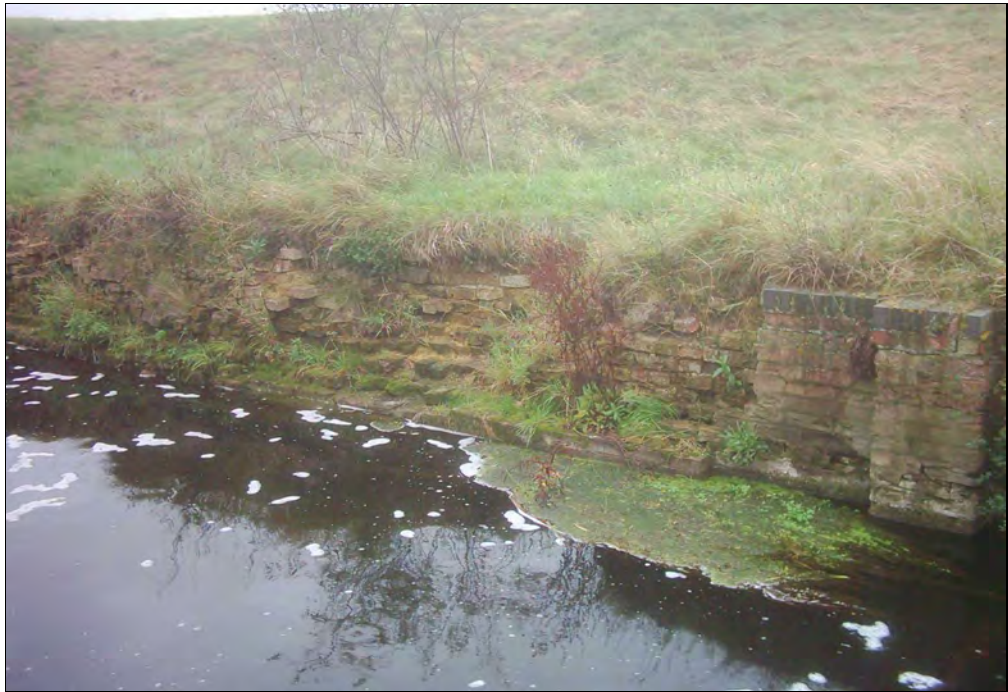
- **Tumby Lock** – This lock has many original features but is in bad state of repair as practically no works have been undertaken at this location for some time. Part of the lock wall on the east bank has been eroded away and several bricks in other parts of the lock have been weathered, as can be seen in Photograph 10.1 below.

Photograph 10.1: Erosion of Tumby Lock Wall on East Side

The top section of the lock has been rebuilt in concrete and has a concrete beam spanning the watercourse. During the walkover survey it was unclear if the top sill remained and if the bottom sill was still intact.

To restore the lock, the top section would need to be rebuilt to include the recesses for the top lock gates and the concrete beam spanning the channel would need to be removed. The lock walls would need to be stabilised and rebuilt in the areas where they have been eroded away. Lock gates would need to be installed and other items associated with the operation of the lock. A bywash would also be required to convey excess water down the canal, especially during times of flooding.

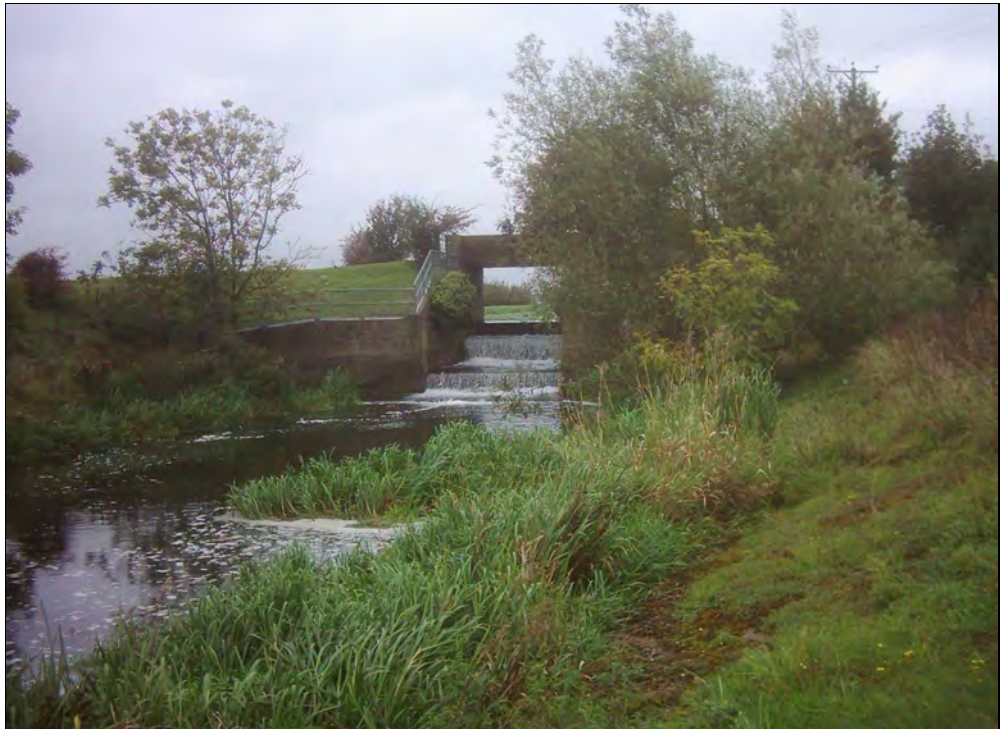
- **Fulsby Lock** – Fulsby lock has been significantly modified since the canal became derelict. There is little remaining of the lock as can be seen from Photograph 10.2 overleaf.

Photograph 10.2: Fulsby Lock's Present Condition

As can be seen from Photograph 10.2 there are three weirs so it was difficult to determine which if any was the original lock sill. One other important fact is that there is no evidence of the downstream section of the lock. The walls have been altered so that they are the same length as the weirs. A concrete footbridge spans the watercourse and there is an important EA gauging station upstream that records both level and flow. This gauge has telemetry and is used for flood warning in Coningsby/ Tattershall.

To reinstate this lock the weirs would need to be demolished and replaced with a top sill. The lock walls would need to be lengthened so that all locks can take the same size of boats. A bywash would be required to convey additional water around the lock, especially during times of flooding. Also the gauging station either needs to be replaced with a modern ultrasonic gauge or moved into the bywash to measure the flow of the canal. A counter to measure the number of lock openings may also be required to measure low flows in conjunction with the flood flows measured in the bywash.

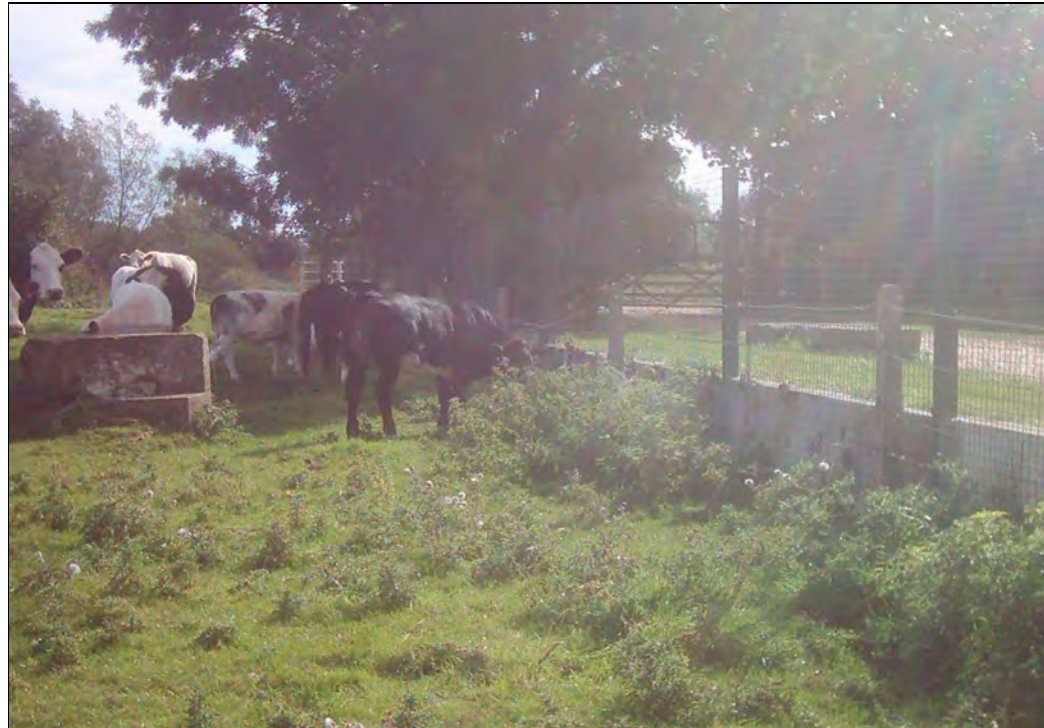
Photograph 10.3: Position of Kirkby-on-Bain Weir (Only Top Stones Visible)

- 10.16. It is not feasible to restore this section of the canal as it would mean that the property would be immediately surrounded by water on both the east and west side. The old millrace was never designed to take boats so there would be major alteration works to the existing weir and access bridge for the property.

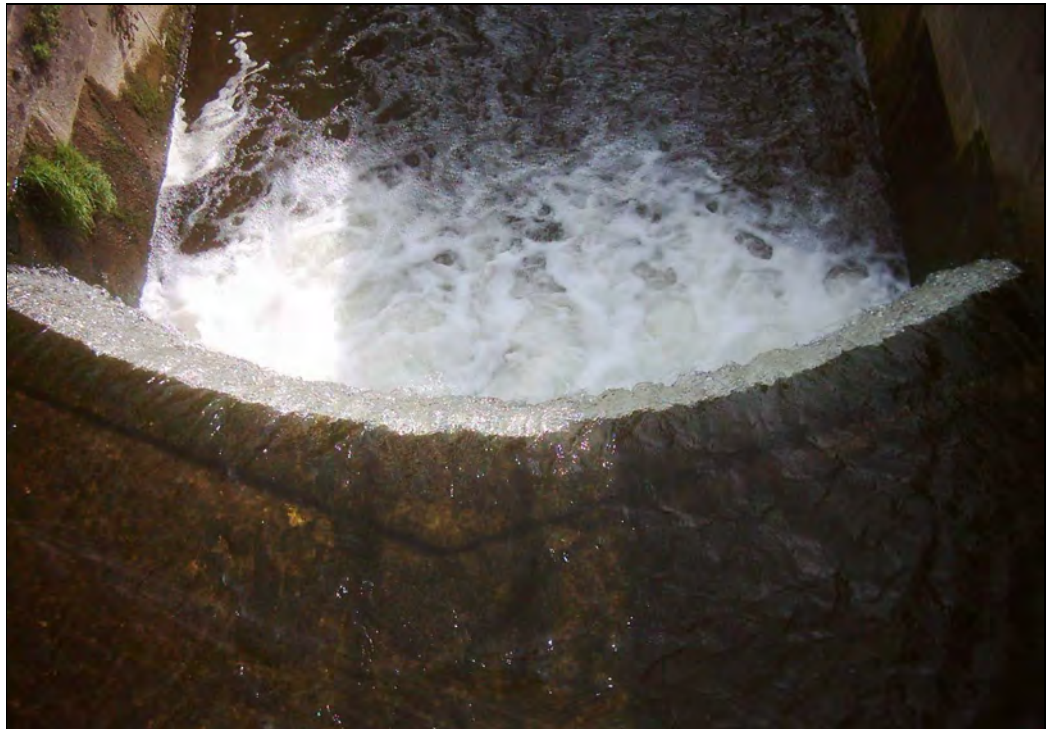
- 10.26. Roughton Lock has been dramatically altered since the closure of the canal, as the lower part of the lock is no longer present. The upper section of the lock has been altered, as there are no signs of gate recesses, and it has a concrete footbridge that spans the watercourse. The one remaining feature of the lock was that the top sill was still intact as is shown in Photograph 10.4 below.

Photograph 10.4: Top Sill of Roughton Lock

- 10.27. To reinstate this structure as a lock, several items need to be rectified, including the overall length of the lock and the lack of headroom under the footbridge. The majority of this structure will need to be rebuilt in order for it to operate as lock. In the upper section, the lock gates and their recesses are required and the footbridge needs replacing. At the downstream section the lock walls need extending so the distance between the lock gates is 23m long. A bywash around the lock to allow the conveyance of flows round the lock is also required.

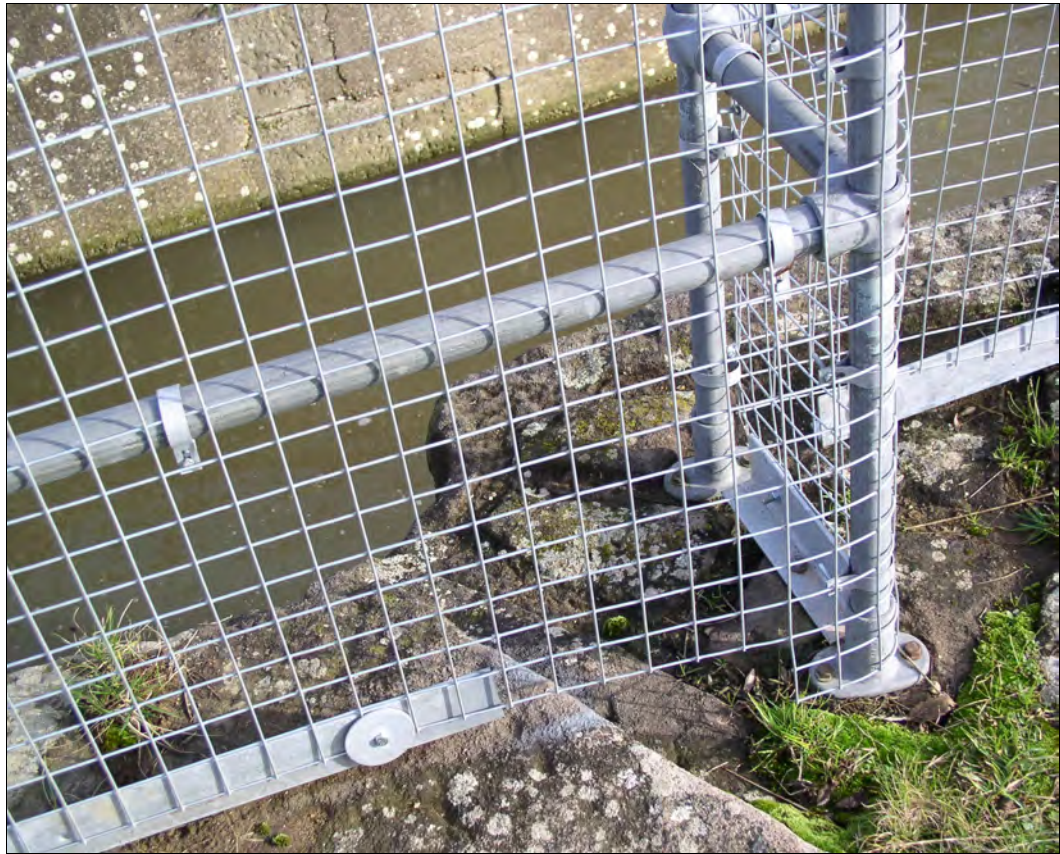
- 10.34. The last lock before Horncastle is called Thornton Lock and is situated to the north of Thornton Road Bridge. This is a very interesting structure as there are many original features that still remain. At present there is a tilting gate attached to the upstream end so it is not clear whether the top sill is present. There were at least two out of the four quoins remaining in the stonework and there were markings in the top stone for the straps that used to attach the lock gates. Photograph 10.5 shows an example of the quoins at Thornton Lock.

Photograph 10.5: Example of the Quoins at Thornton Lock

- 10.35. To refurbish this lock the tilting gate and associated machinery would need to be removed. Two gate recesses are remaining on the west bank however new ones are required on the east bank. A bywash is required around the lock to convey flood flows around the structure instead of over the lock gates.
- 10.36. As well as the locks there are two bridges to take into consideration, these are Thornton Road Bridge and a footbridge upstream of Haltham Lock. With the amount of dredging required, these bridges do not require any raising works but their foundations may need stabilising.
- 10.37. As mentioned above, dredging work are required along this reach of the canal, with the maximum depth of nearly 2m in one isolated area, with the average being around 0.8m. No dredging works are required upstream of Thornton Lock as it has been assumed that no alterations have been made to this sill
