# Bude Canal: Lower Tamar Lake to Burmsdon Section

(Often known as the Bude Aqueduct)

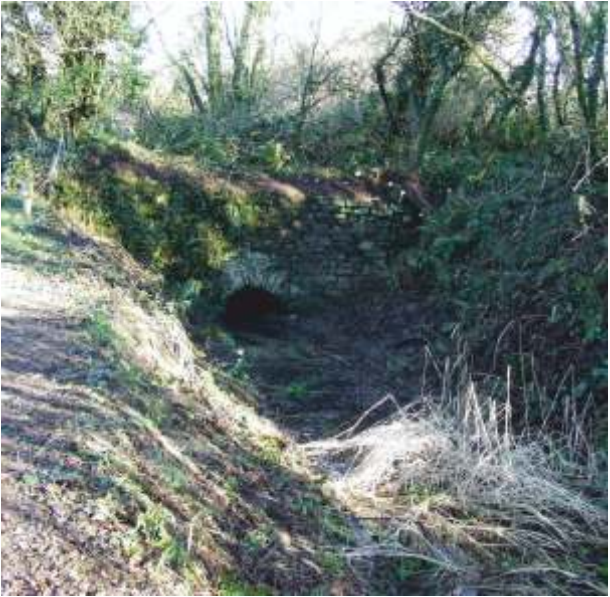
From the car park at Lower Tamar Lake, turn right and follow the lakeside to the footbridge over the Tamar. On the far side is a wooden marker post and cast iron marker indicating the start of the Bude Aqueduct. The small archway on the left marks where the water supply from the lake fed the whole canal system.

A little further on is a sluice gate on the right which controlled the water flow, returning any excess into the Tamar. On the far side note the first of several remaining bound stones marked BHC, indicating the original boundaries of the Bude Harbour Company's land. Note also the more recent marker posts, some with a dragonfly plaque, others with a tub boat cut into the top.

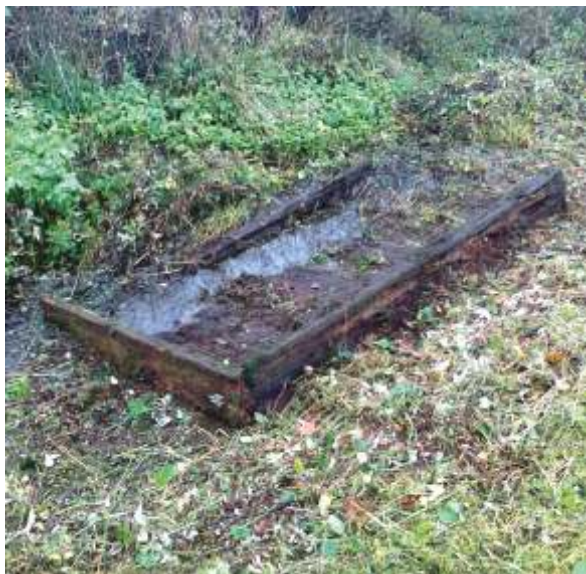
A little further on, the remains of a maintenance boat were recently discovered, now covered again to preserve it.

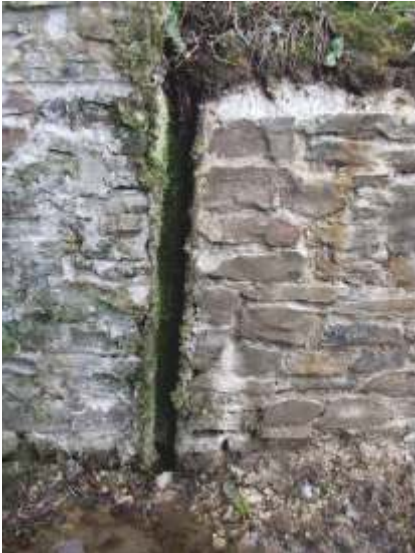
Another accommodation bridge, this one has been rebuilt with a concrete surface for agricultural traffic. The original stone walls have been retained with the cast iron supports included in the reconstruction.

Originally, the bridges were constructed with a slot through the centre, between the cast iron supports and wooden top planking, to allow the tow rope to pass through the gap without the need to uncouple from the horse.

At Wooda (as with all the modernised bridges) this slot has been lost. Also, vertical cast iron channels were built into the side walls at some bridges to accommodate wooden stop boards. These retained the water when repair work had to be done downstream, and these channels are still to be seen at Wooda.

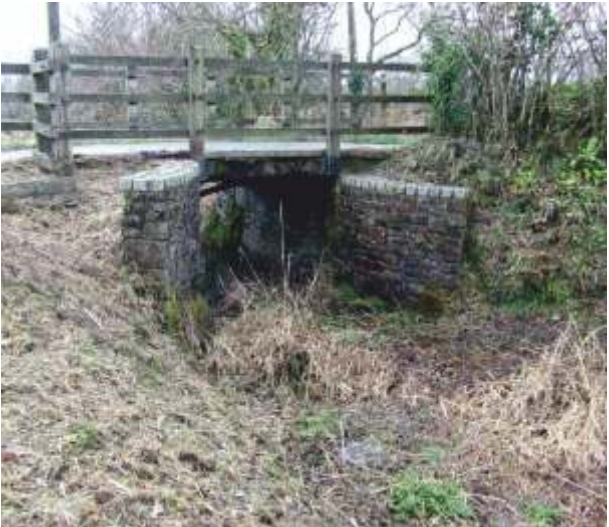
This road bridge has also been rebuilt for modern traffic but the original cast iron support arches have been retained and the 'lead-in' walls on both sides of the bridge have been rebuilt but without the original capping stones.

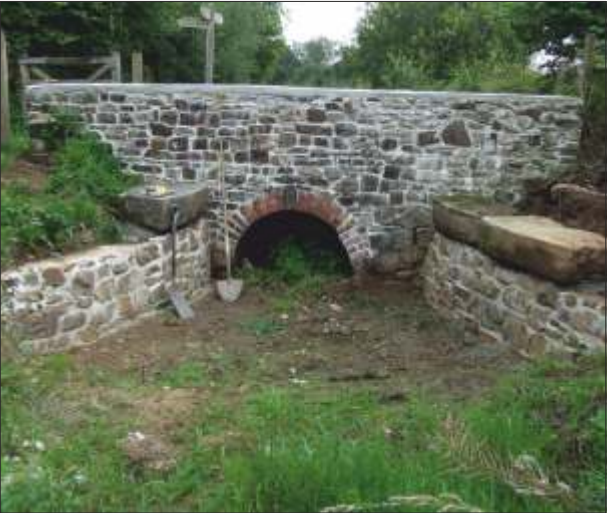
Beyond the junction the canal and its path reach Vealand Bridge. This is the only bridge along the Aqueduct which still had the majority of its large capping stones retained. This bridge had also been rebuilt to include a smaller arch. In 2012 further work was undertaken on the main roadside walls. The lead-in side walls were also reconstructed, including replacing the capping stones.

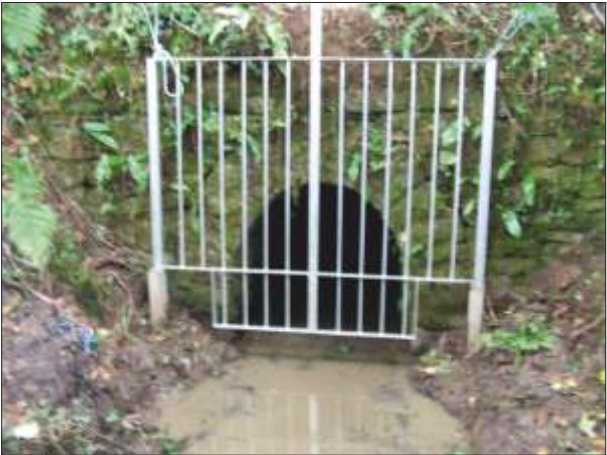
The path now reaches the top of the Vealand Inclined Plane. The Bude Canal did not use locks in its inland section. Instead it used inclined planes, whereby the tub boats were hauled up and down a slope on rails using a water-powered mechanism. A large stone wheel pit was built into the ground at the head of the Vealand Inclined Plane which contained a waterwheel to drive the mechanism which operated the continuous chain attached to the tub boats. No remains of this construction survive, although a little way down the plane on the left the remains of an overspill gully exist. This carried any surge water created by the tub boats approaching the end of the watered section of canal (see information board nearby). A 3 foot/0.9 metre diameter stone-lined culvert was also constructed to carry away the water used to drive the waterwheel. This is no longer accessible.

The Vealand Inclined Plane had a fall of 58 feet/18 metres over a distance of 500 feet/152 metres. To enable the tub boats to use the system they were fitted with cast iron wheels which located on two sets of rails, made up in short sections and bolted into large stones set into the ground down the length of the inclined plane. About half-way down the slope a single stone sett remains in place.
