Aberdulais Aqueduct

Structural Inspection Report

Waterways Recovery Group

Project Number: 10925

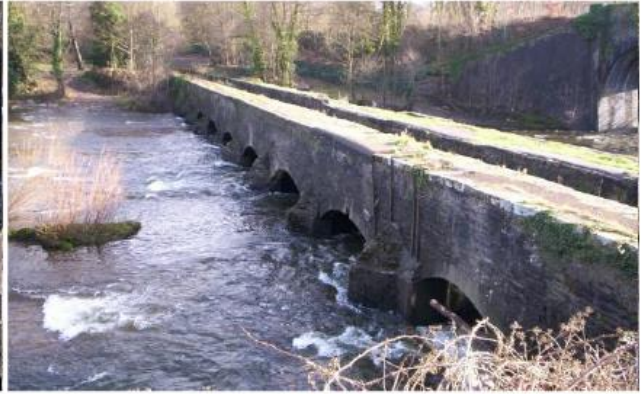
Aberdulais Aqueduct, North side

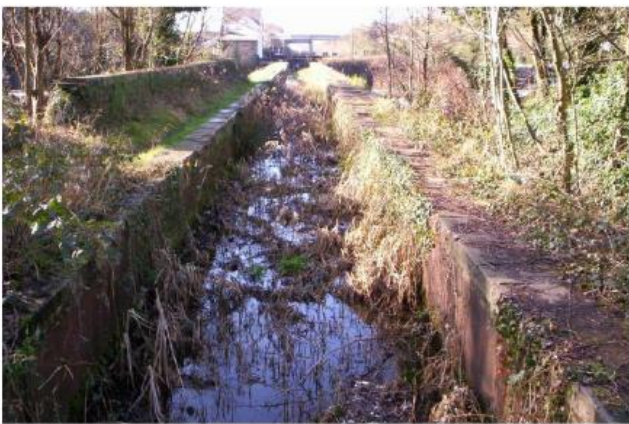
Aberdulais Aqueduct, East end & wall

- Reconstruct the deteriorated 1.15m high masonry wall at the east end of the Aqueduct, south side.
 - The iron trough at the East end of the aqueduct is to be exposed, repaired and repainted.

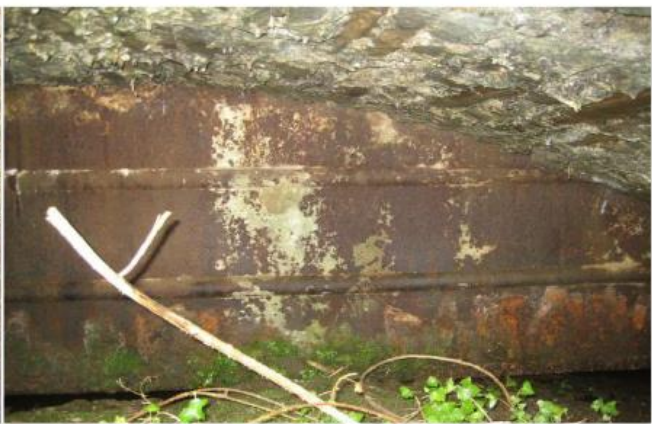
Aberdulais Aqueduct, iron trough

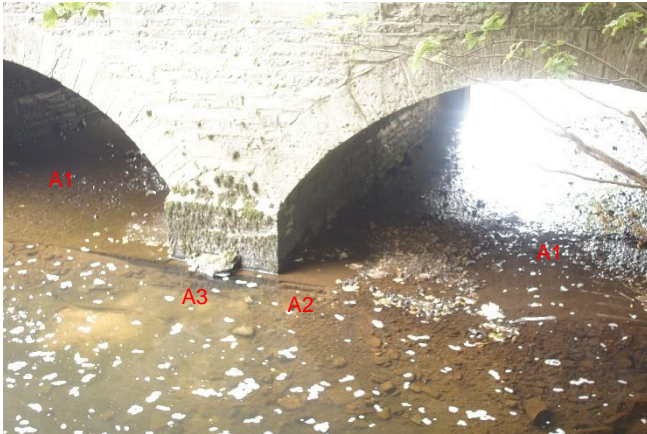
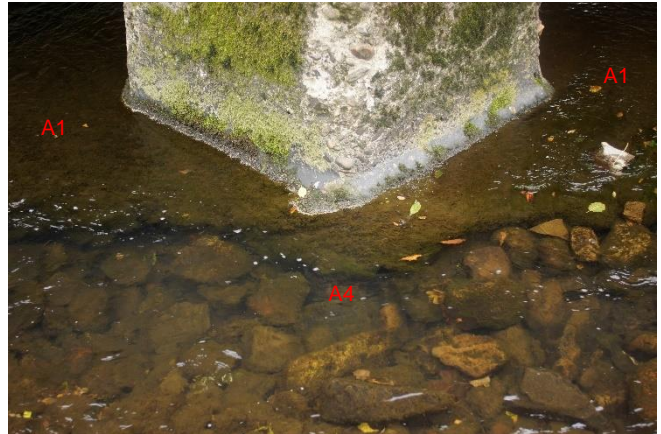
- 4.5.1 The Apron was largely obscured by river gravel and water however, the visible areas suggest there is a level concrete apron (A1) beneath each arch (B). The Apron appears to continue approx. 100mm past the downstream face (A2) and finish flush with the upstream face. It continues past the piers on the downstream face (A3) and under the breakwaters on the upstream face (A4). At the downstream face there is a very slight (approx. 50mm) weir effect caused by the apron.

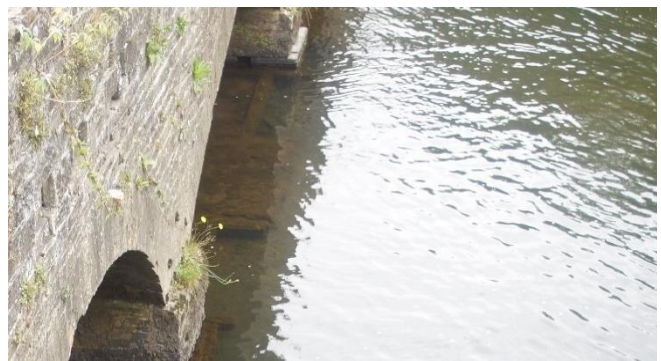
4.5.3 Below arches 1 and 2 the concrete apron does not appear to be present. The 2012 Opus report includes a photo of arch 1 labelled as a timber and stone apron. This appears to show a pitched stone apron with transverse timbers sloping down to the centre of the arch and longitudinal centre and edge timbers. During our inspection, this construction was not visible in arch 1 which was obscured by river debris but was visible in arch 2.

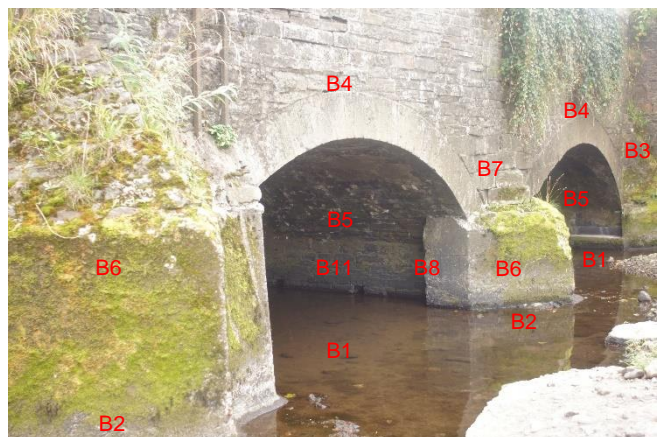
4.6.3 Each pier (B2) has a concrete breakwater (B6) on the upstream face which appears to encase a stone breakwater (B7) these obscure the facing arch springing. The concrete breakwaters are of varying size but are consistently wider than the stone pier and return (B8) into the arch. The downstream face of the piers is rectangular with a slight step out on plan (B9) and a single springing stone (B10).

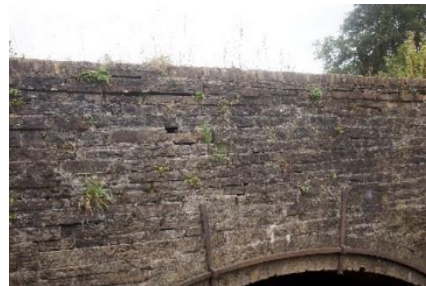
Area of generally reasonable pointing with isolated local loss

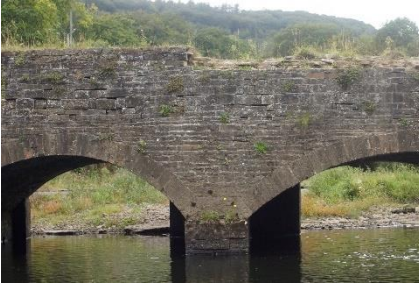
Sparse soft vegetation growth from outside face of downstream channel wall (D).

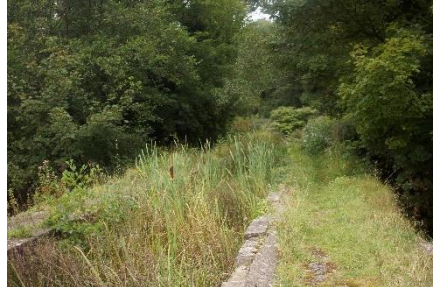
Dense soft vegetation growth in canal channel (E) and variable growth on downstream channel wall head (D and H).

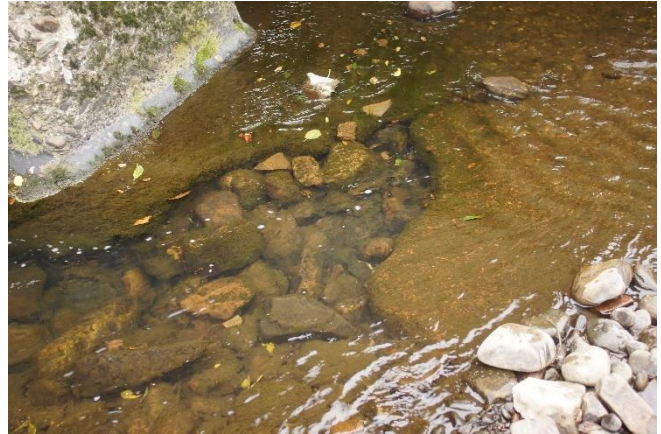
5.4.6.2 On the upstream face the river bed is relatively level with the apron slab (A1) below the arches (B). In one or two locations the bed level was reduced at the interface with the concrete apron but in no locations was it seen to be undermined.

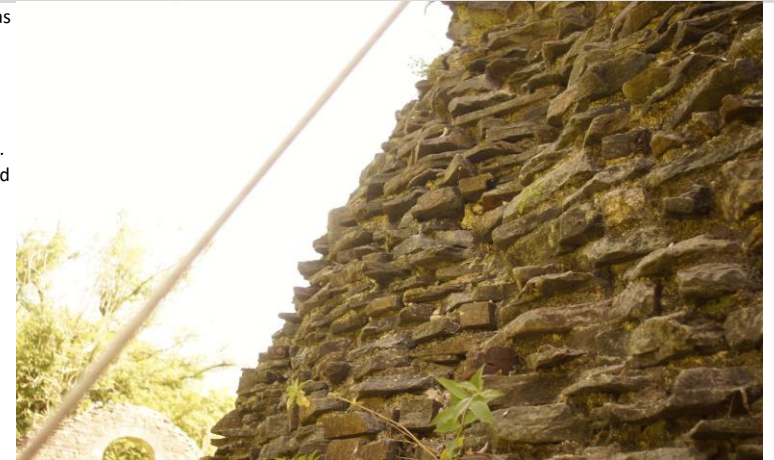
Photograph is of example of previously consolidated core-work on a different project. Some of this area is now in poor condition with loose stones, vegetation and one area of missing stonework but the general arrangement is a good example of the proposed works

Where gaps have formed in the stone facing new stones to be pieced in to match the character of the surrounding.
