Horncastle and Tattershall / Coningsby Canal Heritage Trust (H.A.T.C.H)

The Restoration of Horncastle Canal

Feasibility Study

Environmental Scoping Report

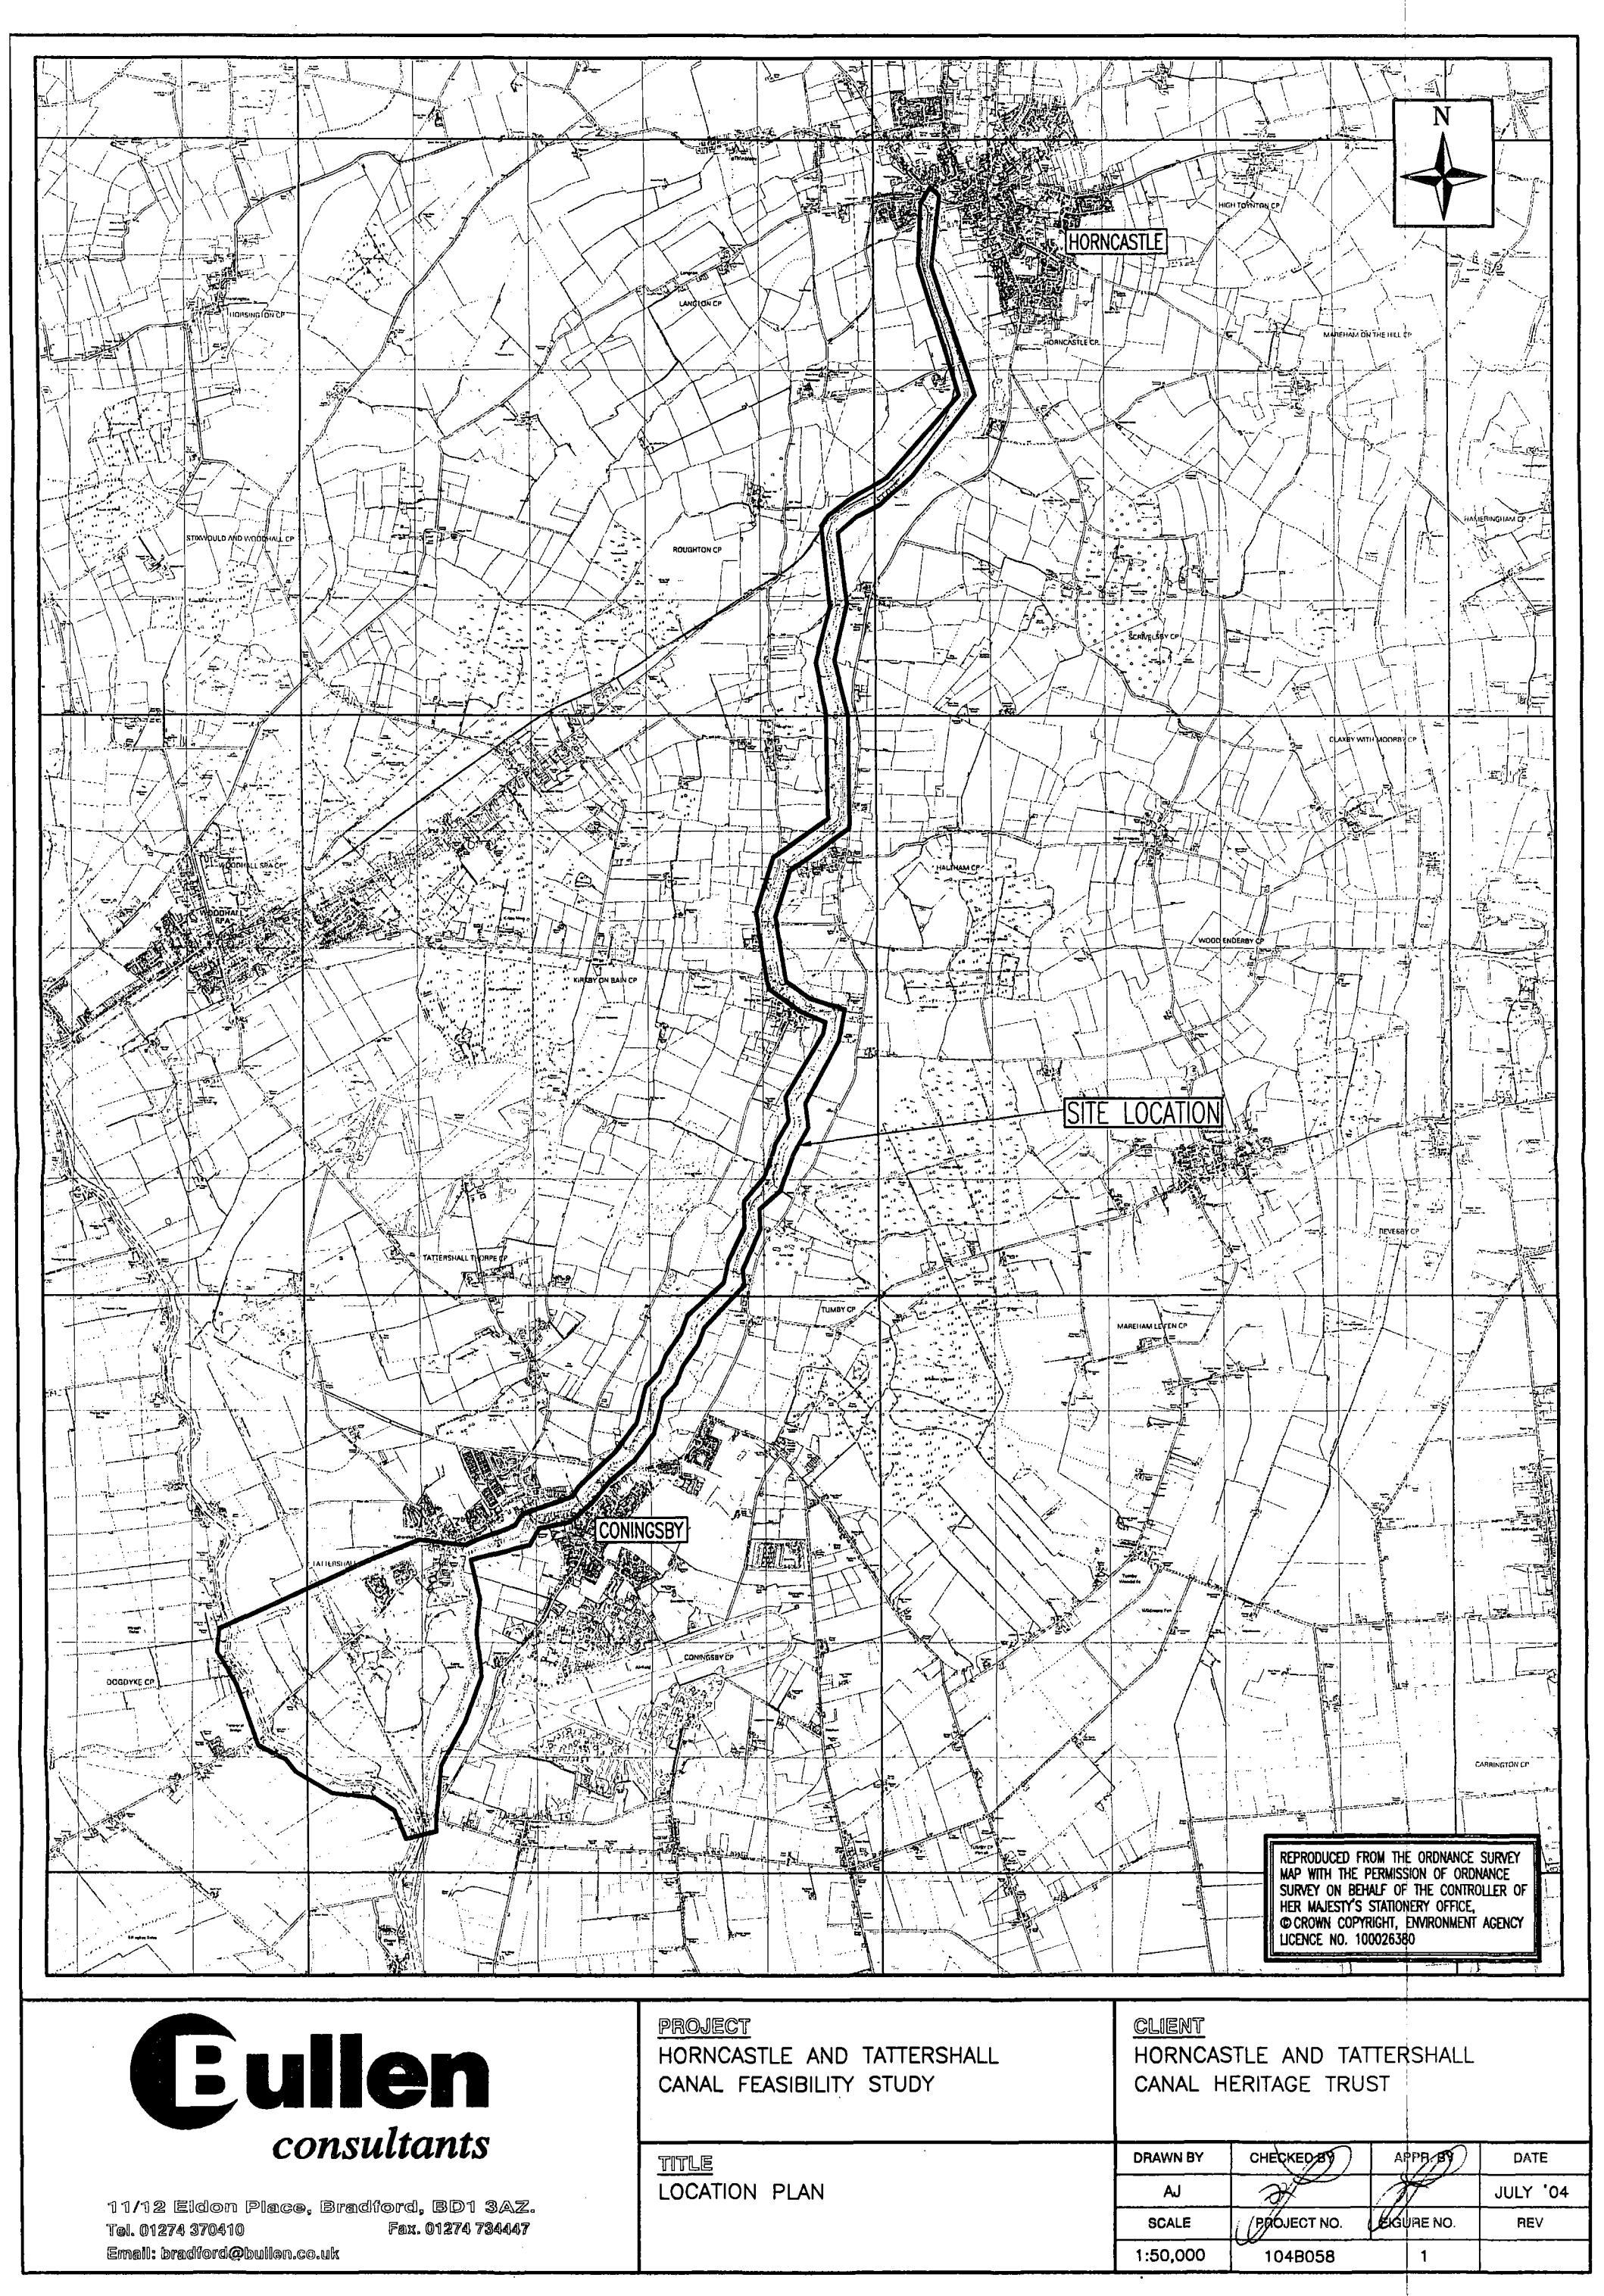
Figure 1 – Site Location

- 1.1.1 Bullen Consultants was commissioned by Horncastle and Tattershall/Coningsby Canal Heritage Trust (H.A.T.C.H) to undertake a feasibility study into the restoration of Horncastle Canal, Lincolnshire. The stretch of canal under consideration runs from the Roman Town of Horncastle through Tattershall (Approximate National Grid Reference TF 261695 to TF 209555). This waterway continues north as the River Bain and to the south of Tattershall joins the River Witham (as shown in Figure 1 Site Location).

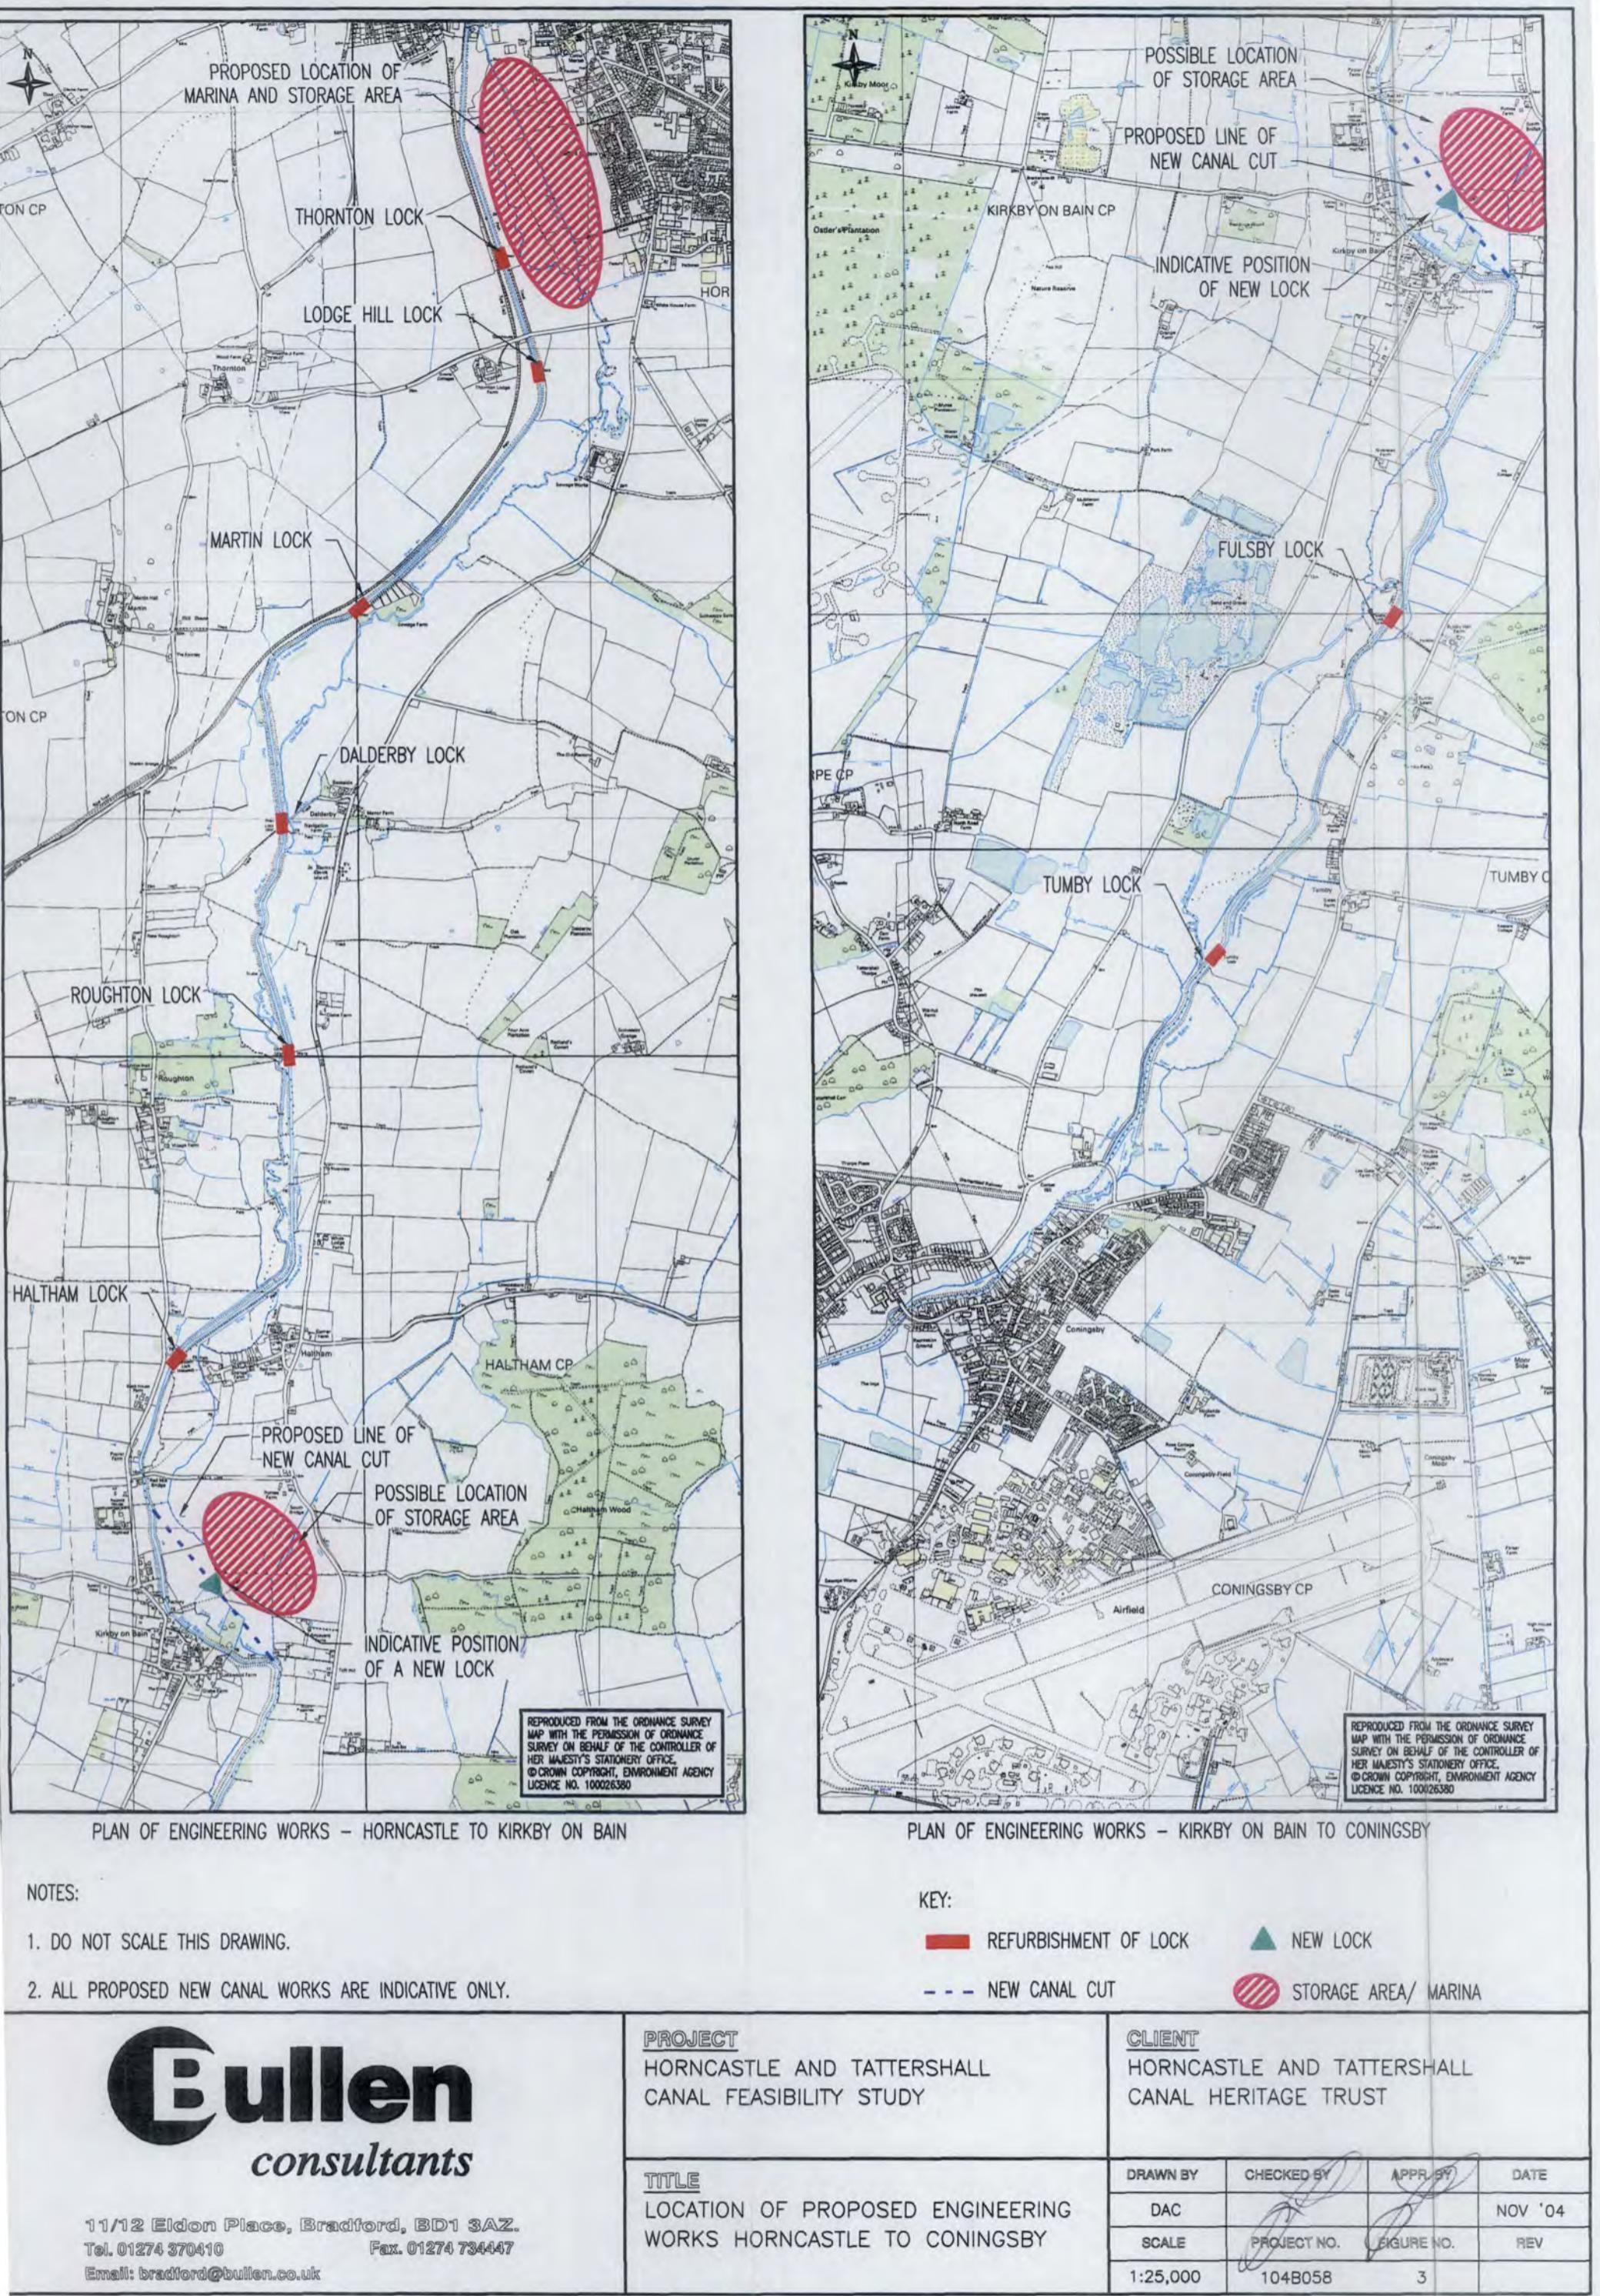
Horncastle to Coningsby Figure 4 – Location of the Proposed Engineering Works

In order to restore the canal into a navigable stretch of water once more, various proposed works are suggested. The proposals will be confirmed during the EIA, but they include;

- Re-installation of the locks along the original alignment of the canal.
- Construction of a new marina and canal storage reservoir and / or pumping.
- The cutting of a new section of canal, including a new lock structure.
- Possible installation of a new canal lining.
- Necessity to either raise existing bridges or deepen the canal channel.
 - Possible actions to maintain or improve the current flooding regime.
- 2.2 .

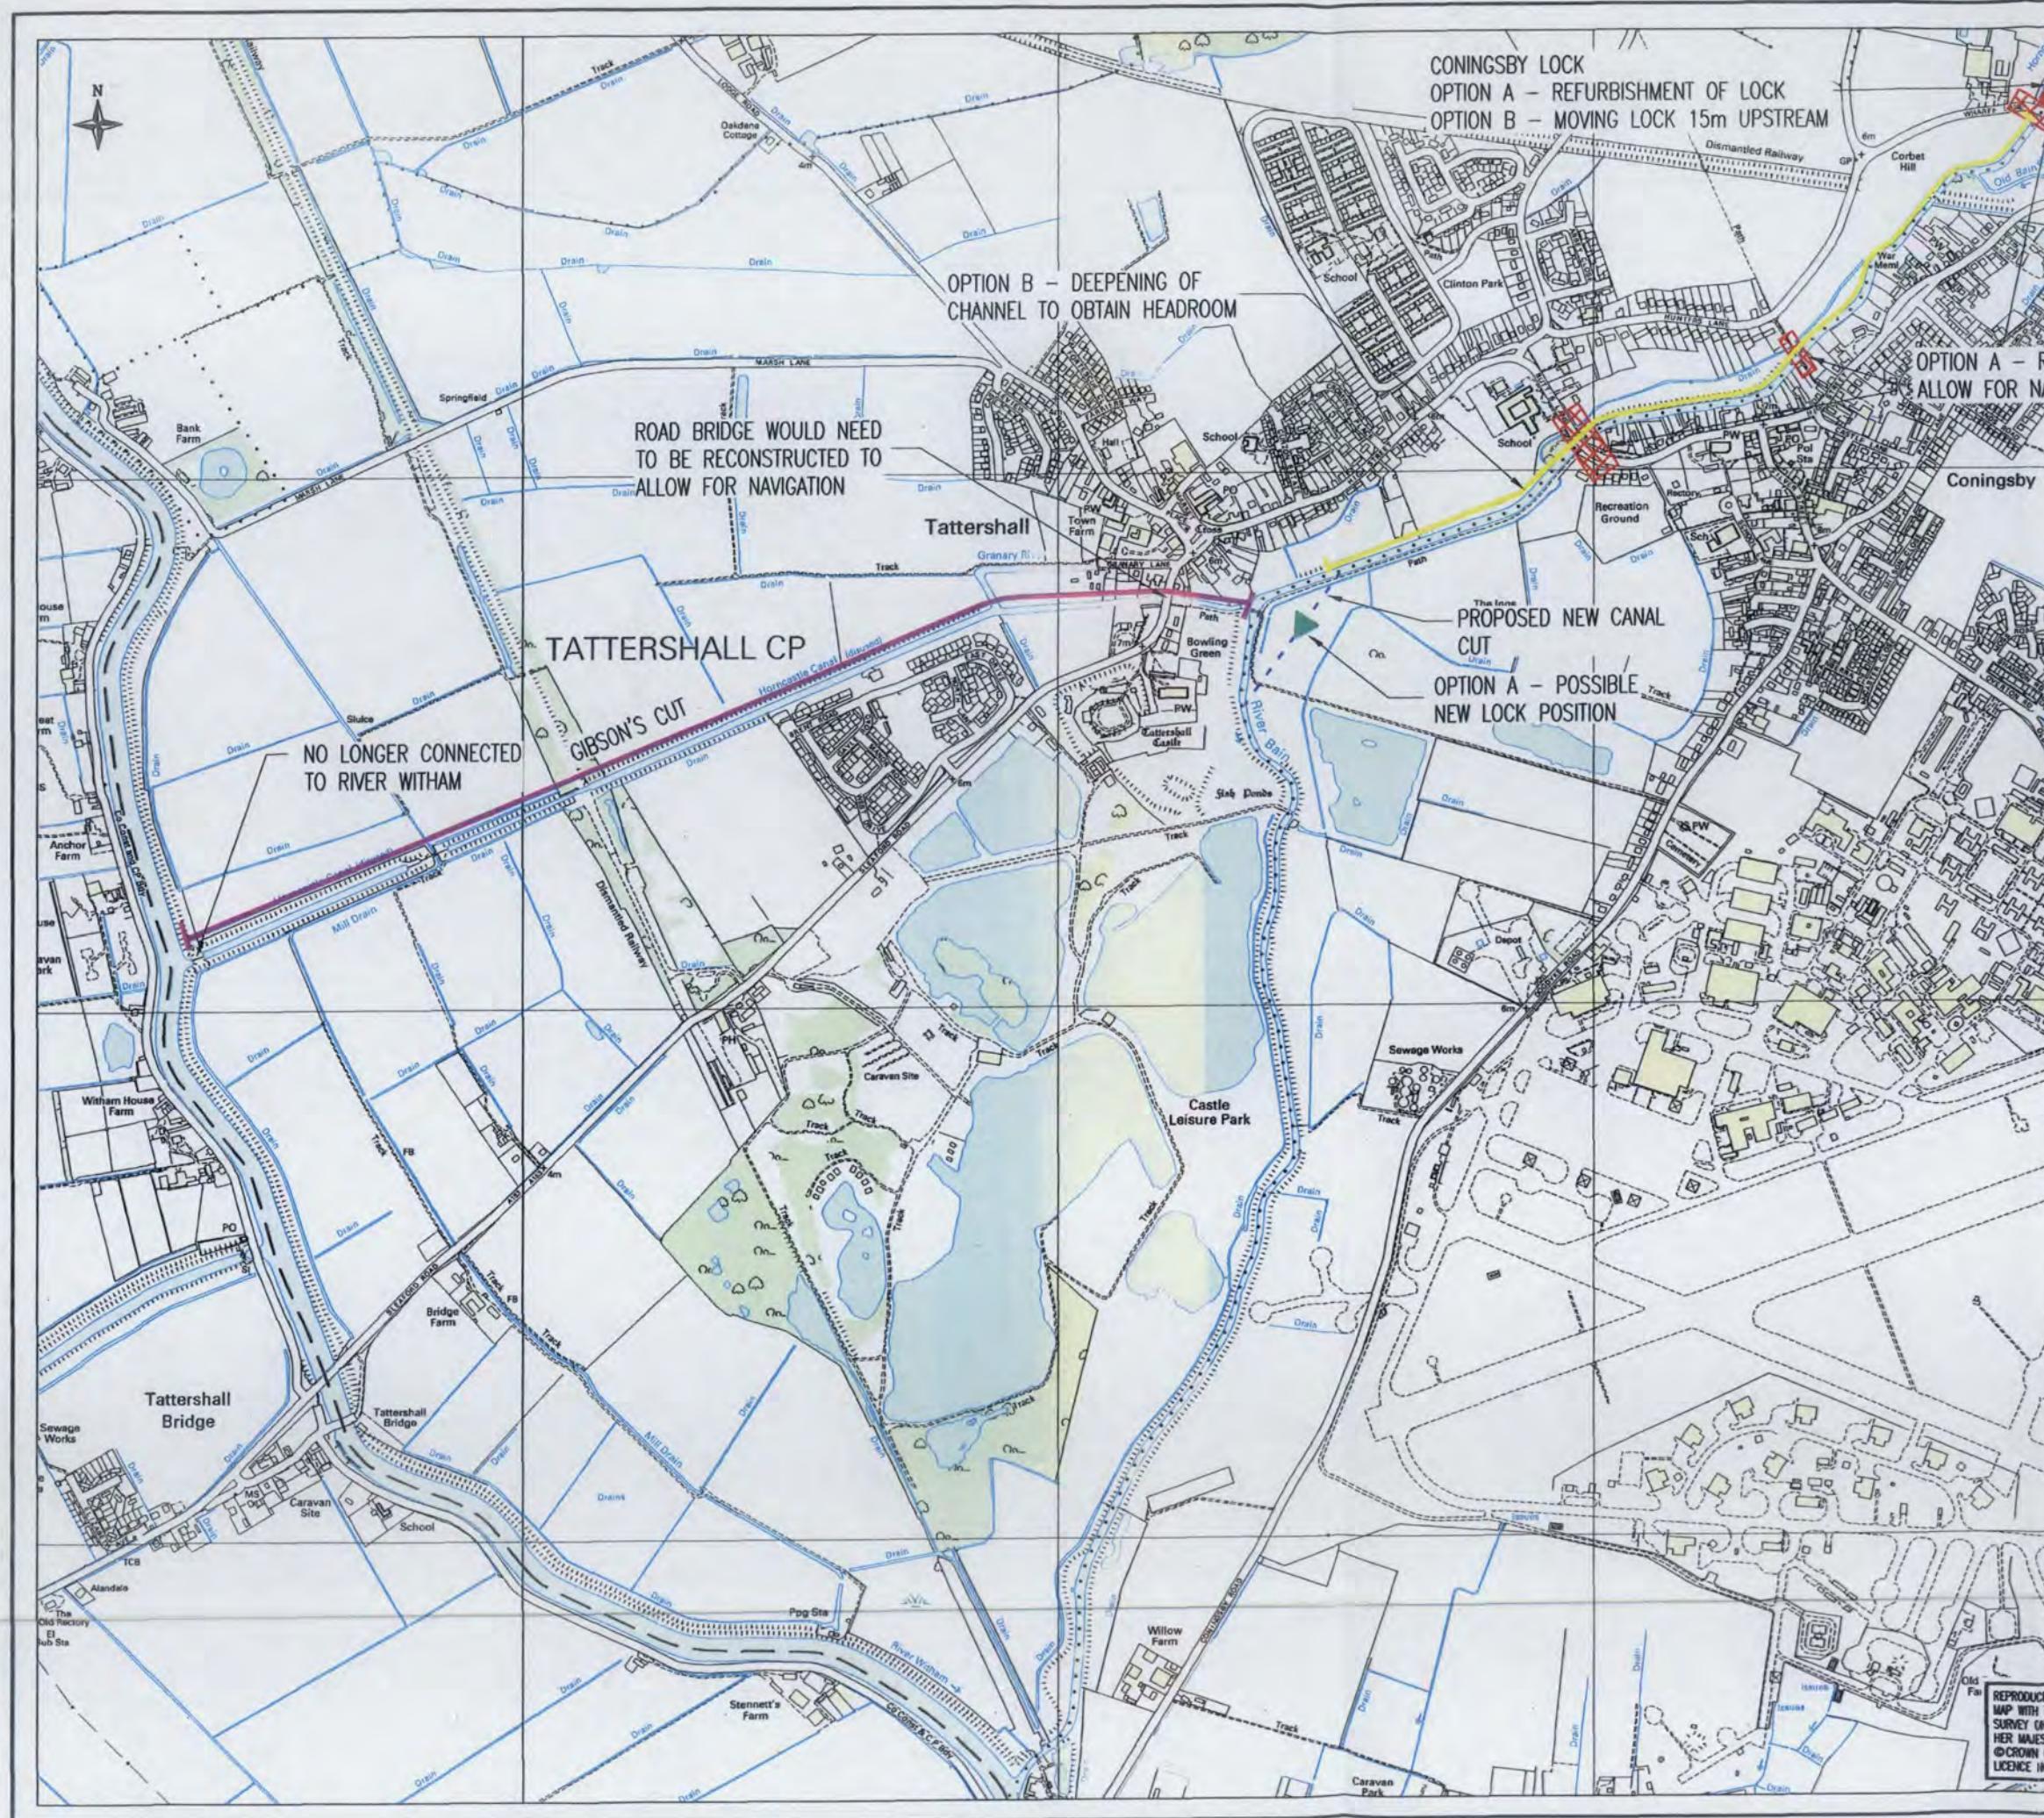
Coningsby to the River Witham

- 3.2.3 The Leakage rate requires further investigations and where there is a problem then a new lining will be provided.
- 3.2.4 Between Coningsby and the River Witham there are two main options that the route of the canal could take, Figure 4 shows the Location of the Proposed Engineering Works for this stretch. Originally there were two entrances to Horncastle canal below
